HISTORIC PRESERVATION CERTIFICATION

APPLICATION — PART 1

NAME OF PROPERTY: _____
Address of property Street 610 Cathedral Street
City Baltimore County _____ State Maryland Zip Code 21201
Name of historic district in which property is located Mt. Vernon Historic District: National Historic Landmark District, 1971; Baltimore City Historic District, 1964

B-3896
610 Cathedral Street
Block 0532, Lot 006
Baltimore City
Baltimore East Quad.

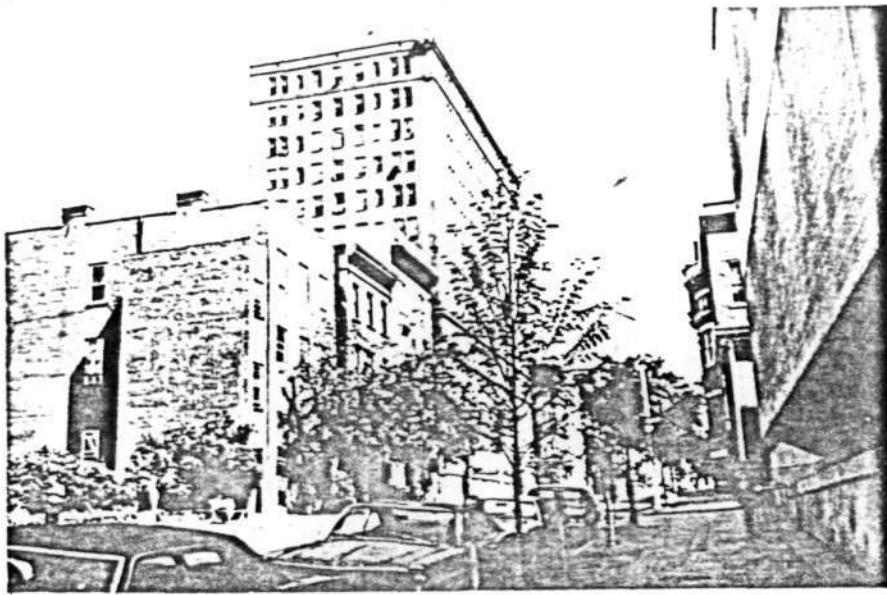
PART 1 PHOTO 1

610 Cathedral Street exemplifies the elaborate, heavily detailed rowhouses found in the Mount Vernon Historic District. Buildings such as it blend with one another to create the significant architectural environment of the district. This building is an Italianate style, five story, two bay, masonry attached house with a brownstone and running bond brick facade, a low basement, and a shed roof.

The east facade base of the structure has a brick water table, basement window well in its north bay, and marble steps with raised cheeks leading to the main door in the southern bay. The entire first floor facade is rusticated brownstone that has been painted. The door and window openings are identical, consisting of paneled brownstone surrounds beneath ornate brownstone consoles supporting a hood. Within this frame is a round arched opening with an architrave surround, central keystone in a scroll form, and recessed paneled spandrel areas. The main door is paneled, stained and recessed within a paneled vestibule. There is a leaded glass transom above the door. The window consists of two coupled, round arched, wood one over one double hung windows with molded surrounds and a wrought iron window box.

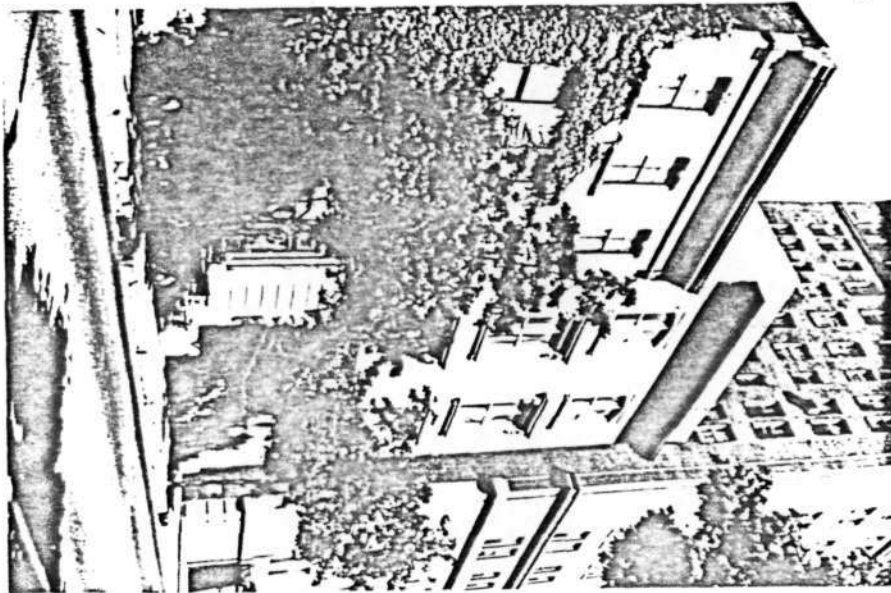
PART 1 PHOTO 2

Both of the hoods support a cast iron balustrade in front of the second story windows. These windows also have hoods with consoles and panels below as well as molded surrounds. The windows here and throughout the east facade are ornate coupled, arched, one over one double hung wood windows which conform to the profile of the opening. This floor and the remainder of the facade consists of painted running bond brick.
